## Surface Characterization of Retrieved Metal-on-Metal Total Hip Implants from Patients with Adverse Reaction to Metal Debris

**Abstract:** The use of metal-on-metal (MoM) total hip implants has decreased recently due to reports of high failure rates and adverse local tissue reaction (ALTR). It has been hypothesized that wear metal debris released from CoCr bearing surfaces may provoke delayed hypersensitivity reactions. The goal of this study is to evaluate the microscopic bearing surface characteristics of implants revised due to evidence of ALTR. The bearing surface of each head and cup was analyzed using multiple microscopy techniques for characterization of the surface features. The presence of severe mechanical scratching was a common characteristic found in all of the implants evaluated. Mechanical factors seemed to be the prevalent failure mode related to the appearance of ALTR with this particular set of retrieved implants.

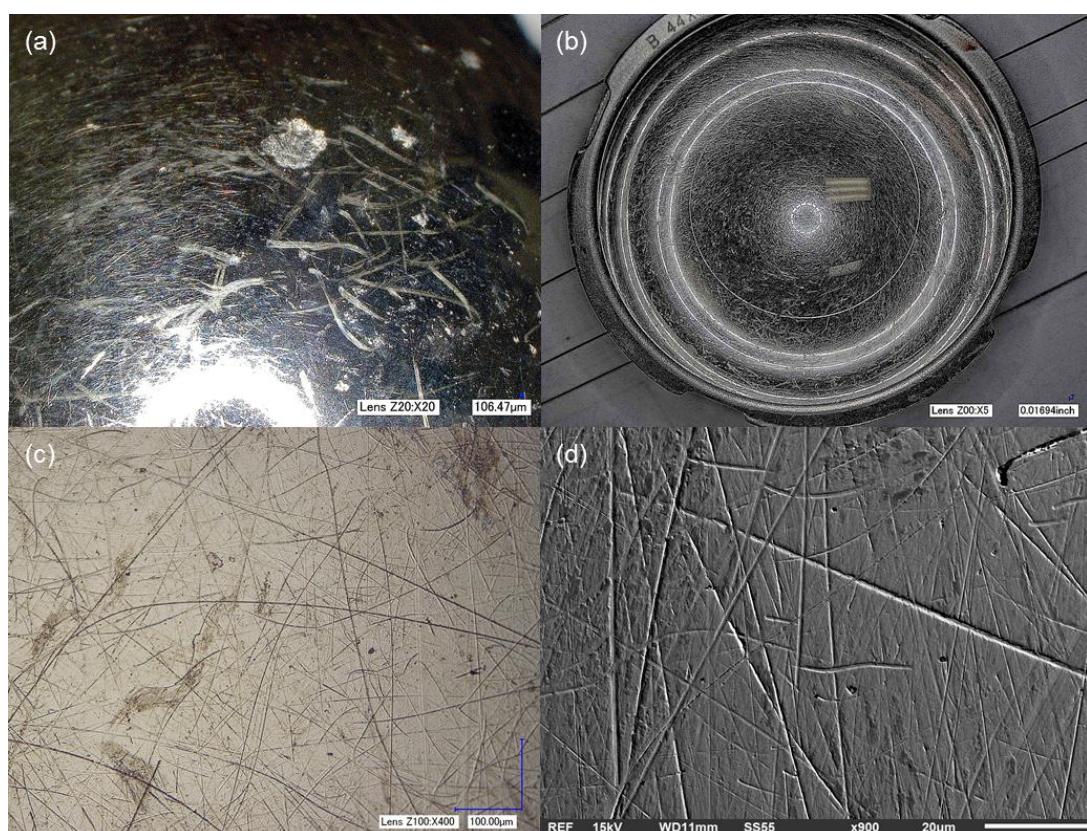
The four implants selected for the study presented ALTR at the time of surgical removal. All the implants consisted of CoCr MoM head-cup systems (Implants 2, 3 and 4) with the exception of Implant 1, which had a Ti6Al4V/CoCr head-cup combination. At the time of revision surgery, the head-neck taper junction was visually examined by the surgeon for any evidence of corrosion. Black debris in or near the taper junction was considered to be potential corrosion products, and the implant was recorded as having *in vivo* corrosion. Implants with no evidence of debris deposition near the head-neck taper junction, or if debris was deemed to be biologic in nature, were recorded as having no *in vivo* corrosion. Implant 1 was observed to have evidence of *in vivo* corrosion, at the time of revision surgery. However, upon microscopic inspection, the sample showed no evidence of corrosion features (pitting attack, etching, surface/bulk attack) on its surface. The articulation interface of the head and the cup was highly scratched as shown in Figure 1a,b.

**Figure 1.** Severe scratching observed in specimen 1: (a) femoral head and (b) acetabular cup of Implant 1. Deep scratches were revealed during the analysis, which led to the hypothesis of a large amount of particle generation *in vivo*; (c) optical micrograph demonstrating scratch depth; (d) SEM micrograph showing no features other than scratching. The surface was clean of biological or corrosion products.

The level of scratching on the head was quantified using the depth up microscope technique (Figure 1c). The total area scratched was  $671\text{ mm}^2$  out of a total head surface area of  $3926\text{ mm}^2$ . This results in approximately 17% of the surface of the head affected by scratching. Using the clinical information, an estimated area of material lost from the scratches per year of implantation was approximately  $152\text{ mm}^2/\text{year}$ . Surface analysis, with the 3 different microscopy techniques, of the interfaces of this implant did not reveal any mechanisms other than scratching, as illustrated in Figure 1d. EDS analysis of areas that exhibited scratches showed similar composition to the areas of the implants with no characteristic damage ranging from 5% to 7% Carbon (C), 28% Chromium (Cr), 62% Cobalt (Co) and 3%–7% Molybdenum (Mo). Scratched and unscratched surfaces did not present a significant change in their elemental composition in all the specimens evaluated.

An individual analysis of each of the samples is necessary to characterize the different factors that lead to the formation of an ARMD. In the case of Implant 1, it was found that the cup had an abduction angle of 57 ° and a head of 44 mm in diameter. These characteristics classify the head as large and the cup abduction angle as outside of the *Lewinnek Zone* [17]. It has been reported that MoM soft tissue reactions are more likely to be found in hip prostheses with heads between 38 and 49 mm of diameter and with cup abduction outside of the *Lewinnek Zone*, which is defined between 5 °–25 ° for anteversion and 30 °–50 ° for abduction [17,21]. In a study of 2600 cases of hip resurfacings, Gross *et al.* [22] found a low incidence rate of pseudotumors, ranging from 0.1% to 1.8%. However, all of the failures that presented pseudotumors had small head components (less than 48 mm) and abduction angles greater than 50 ° [22]. Acetabular inclination is thought to be an important factor that contributes to increasing wear rates and metal particles, which increases the probability of developing a pseudotumor [21,23,24]. However, some studies have shown that there is not a significant correlation between metal serum levels and angle of cup inclination [25,26]. Thus, both studies acknowledge that accurate cup positioning lowers the possible risk of implant failure. The need for revision of Implant 1 was most likely due to its high cup abduction angle, which led to an uneven distribution of forces and stresses on the implant, inducing the observed scratching. The estimated surface area loss due to scratching (17%) is significant and may indicate that a high amount of metal ions and debris was released from this interface. Such an influx of foreign metal ions into the body may have led to the formation of an ARMD.

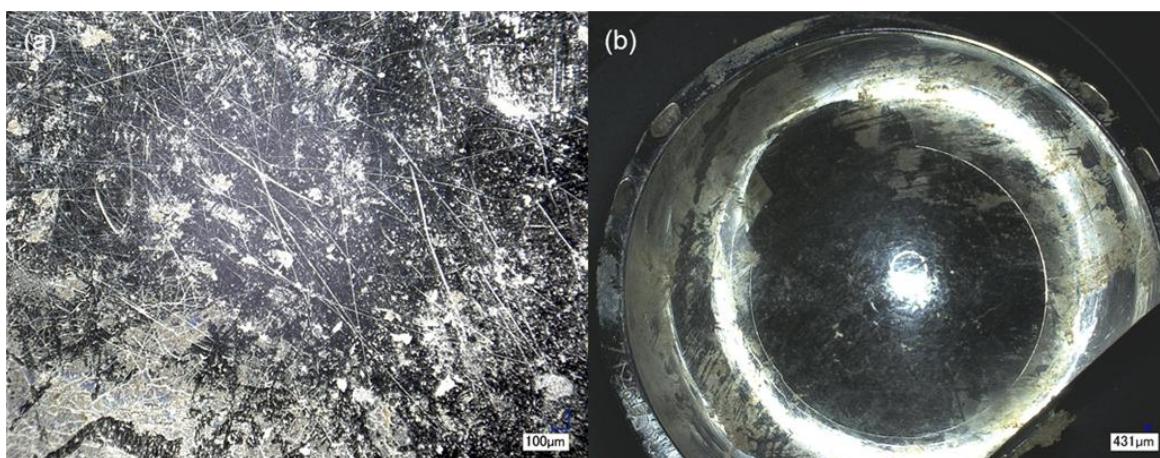
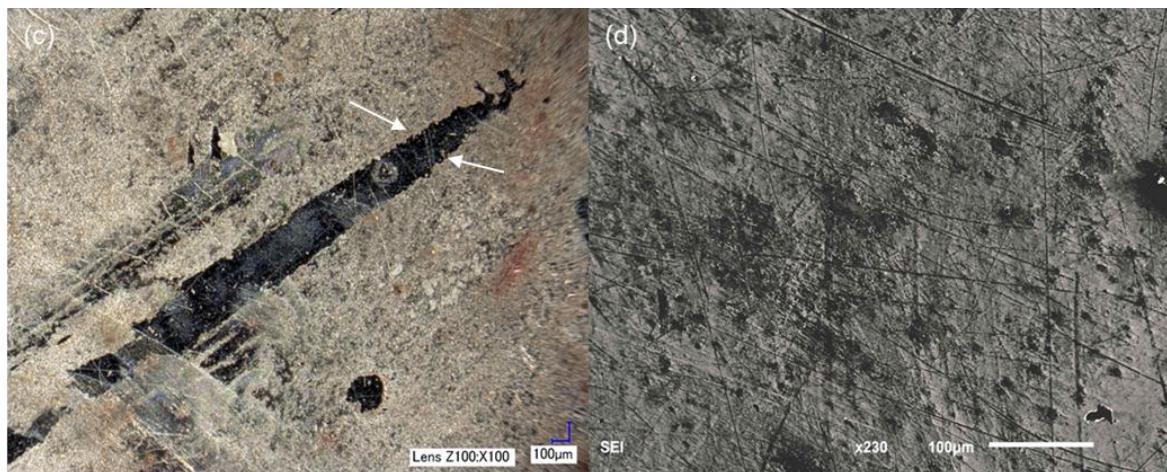
Implant 2 was recorded as having *in vivo* corrosion upon revision. Similarly to Implant 1, microscopic inspection, showed no evidence of corrosion features. However, this sample did present a large amount of debris on its surface, which appeared to be of biological origin and from wear of the top surface (delamination), as illustrated in Figure 2c,d. The level of debris was such that the head-cup ensemble was fixed in a non-rotational position. The nature of the debris was studied under SEM and EDS. A control section of the implant head with no deposition on its surface showed presence of 60% Co, 28% Cr and 5% C with traces of Mo and other trace elements. The analysis of a debris covered section of the implant showed 47% C presence, 8% Nitrogen (N) and 8% Oxygen (O); with only 23% Co and 12% Cr. In addition to these features, a large amount of scratching was observed in both the head and the cup. The results of the microscope analysis found a scratched area of the head of approximately  $1309\text{ mm}^2$  in a total surface area of  $7971\text{ mm}^2$ . This resulted in an approximate total area loss of  $350\text{ mm}^2/\text{year}$  from the head-cup interface. The percentage of surface scratched on the head was 17.5%. No etching or discoloration of the interfaces of the implant was noted.

**Figure 2.** Surface condition of Implant 2: (a) optical micrograph of the scratched and debris covered surface of the head; (b) optical micrograph of the scratched surface of the cup; (c) optical micrograph showing areas of the head with high degree of biological deposition on the surface and delamination of top layers (arrows). A large amount of metal debris could be expected from this area of the implant; (d) SEM micrograph showing surface irregularities, scratches, and debris covering the surface of the head of Implant 2.

From studying the surface of Implant 2, the nature of the debris covering the surface of the prosthesis was likely biological, a probable result of bodily fluids entering the rotational areas of the implant. The reason for revision of Implant 2 is similar to the mechanism observed with Implant 1, likely related to its highly scratched surface (Figure 2) that released metal particles into the surrounding soft tissues, causing an inflammatory reaction and the development of ARMD. The scratching in this implant was characterized and resulted in a 17.5% of area scratched.

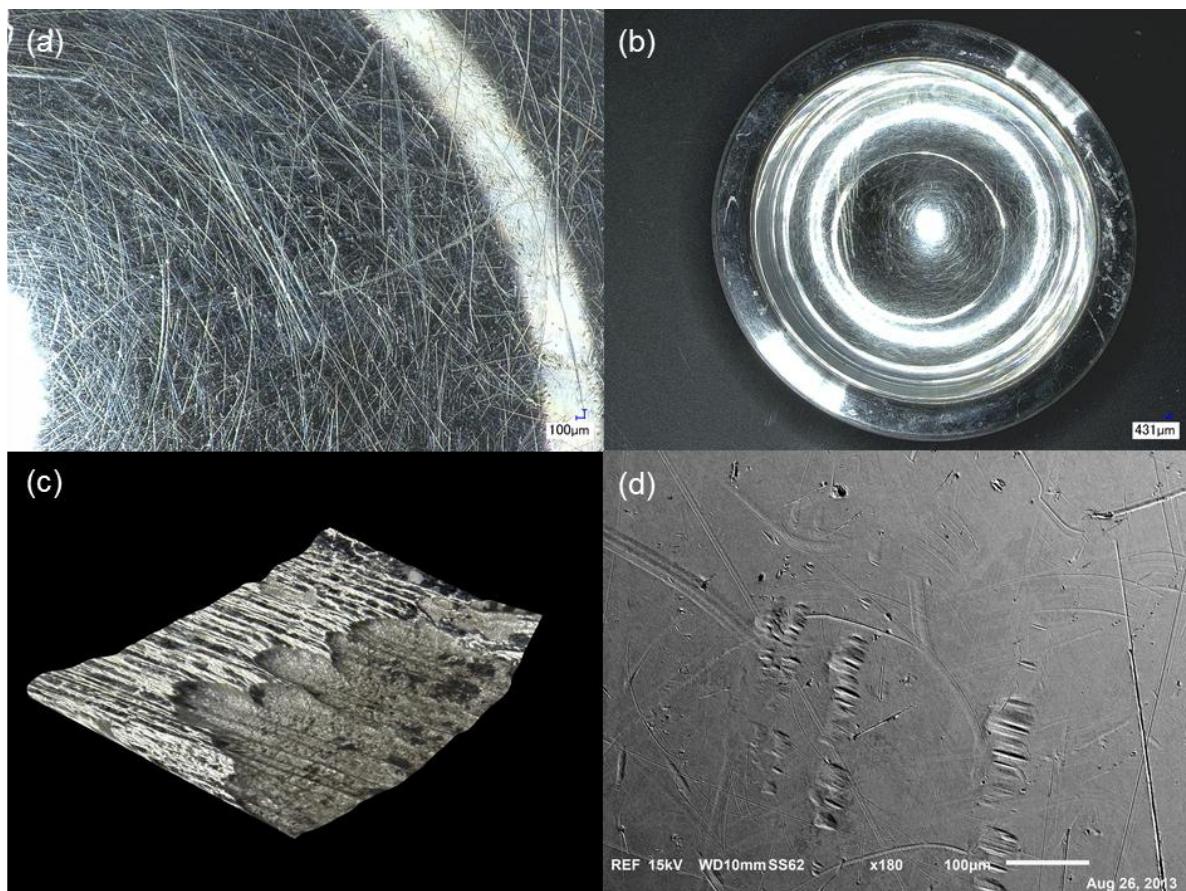
The study of Implant 3 under digital microscopy revealed severe scratching in the head and cup areas as demonstrated in Figure 3. The total scratched area was  $322 \text{ mm}^2$  out of a total head area of  $2532 \text{ mm}^2$ , which constitutes 12.7% of area scratched and an estimated area lost per year of approximately  $29 \text{ mm}^2$ . This implant showed signs of *in vivo* corrosion at the time of surgery. Initial inspection revealed the possibility of corrosion in the implant's head-neck modular connection due to significant surface discoloration, which was evident in the implant neck (violet and yellow discoloration). SEM analysis of the female taper of the head showed delamination of the metal surface with exposure of the metal bulk as illustrated in 3D in Figure 3c. EDS results showed the presence of 30% Co, 20% Cr, 9% Mo, 21% C, 19% O and other elements, on the non-delaminated surface of the head-neck connection surrounding the corroded delaminated area. Some small traces of Titanium (Ti) (<1%) and Aluminum (Al) (~1%) were found in this area, which were originated from wear of the implant neck (Ti6Al4V neck fretting against the female taper of the head counterpart). Analysis of the surface exposed due to delamination showed the presence of 58% Co, 27% Cr, 6% Mo, 7% C and 1% O, which confirmed bulk exposure (Co and Cr rich) due to removal of the top oxide-film containing surface. Similar to the other two implants, there was no evidence of etching, discoloration or corrosion debris present in the head and cup couple analyzed. The corrosion was only found in the female taper; the rest of the implant (surface of head and inside of the cup) only showed signs of deep scratching similarly to the other implants discussed, as observed in Figure 3a.

**Figure 3.** Surface condition of Implant 3: (a) optical micrograph showing the scratched surface of the head of the implant; (b) optical micrograph showing the highly scratched interfaces of the cup; (c) 3D optical micrograph revealing delamination, bulk exposure and corrosion products on the surface of the modular connection of the head female taper; (d) SEM micrograph showing scratching and fretting marks on the surface of the head.

Upon investigation of Implant 3, optical microscope, SEM and EDS analysis confirmed the presence of corrosion on the female taper of the head-neck modular connection. The modular head-neck interface underwent fretting-crevice corrosion, which likely generated titanium ions and debris that deposited into the head-cup articulation accelerating wear [8], and in this particular case, leading to the formation of ARMD. The modularity of hip implants allows for small displacements in the individual modular connections that can induce fretting-crevice corrosion. It has been reported that main concerns related to head-neck tapers are their tendency for corrosion and accelerated wear, especially with mixed metals, thus releasing large concentration of particle debris [27,28]. A similar result was found in a recent case report that showed the formation of a pseudotumor in a 72 years-old patient as a result of corrosion and wear products that arose from the modular head-neck interface of a hip hemiarthroplasty [29]. In addition to corrosion observed in the head-neck area, the high level of scratching found on the surface of both the head and cup (Figure 3) also contributed to the formation of wear particles that resulted in the ARMD. The scratching level was quantified, as in the previous implants, revealing a 12.7% area scratched.

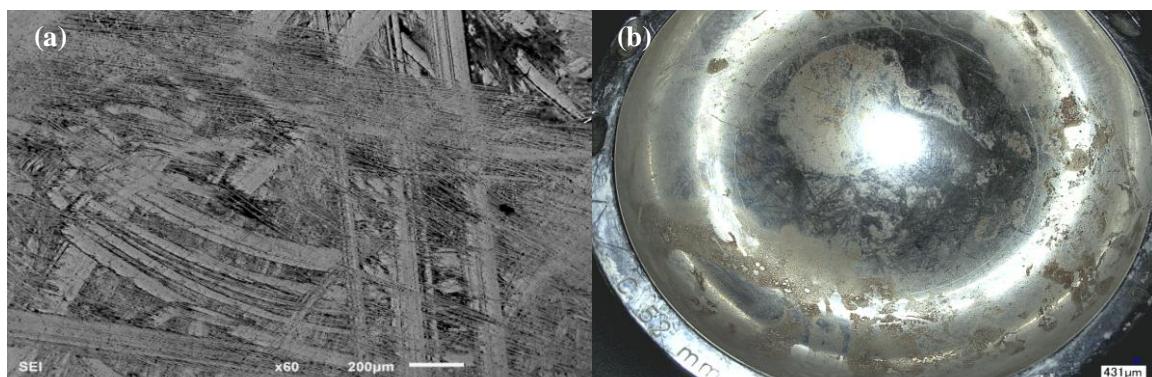
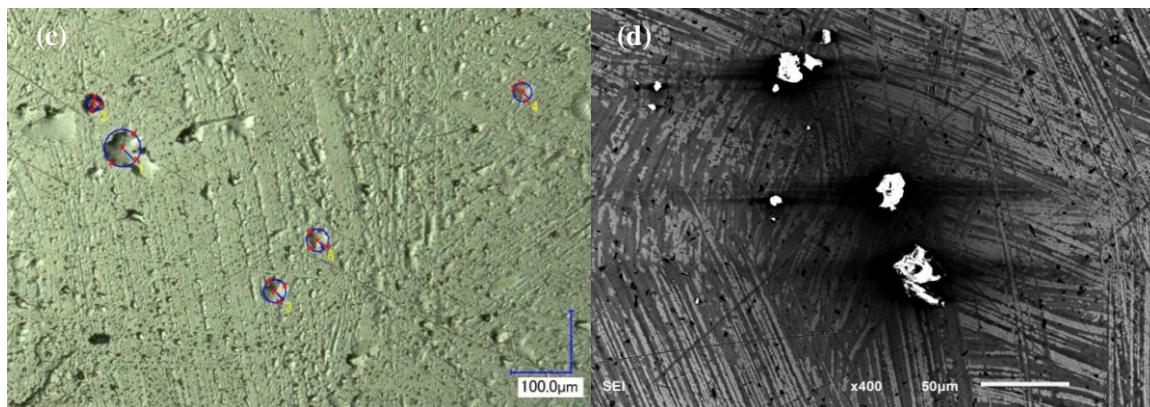
As in the previous cases, Implant 4 demonstrated evidence of corrosion at the moment of revision surgery. The microscopy study of this sample revealed deep scratching similar to that observed in Implants 1, 2 and 3, as illustrated in Figure 4. The level of scratching in this implant could not be quantified due to the fine and homogeneous distribution of the scratches (Figure 4a) throughout the implant making these indistinguishable from the non-scratched surface. Biological deposition similar to that observed in Implant 2 was found on the surface of both the head and acetabular cup. EDS analysis yielded similar results as observed in Implant 2. Other than severe scratching of the implant head and cup couple, there were no signs of surface cracking, corrosion, or etching in the analyzed areas of this specimen.

**Figure 4.** Surface condition of Implant 4: (a) SEM micrograph of the homogeneous scratching on the surface of the head; (b) optical micrograph emphasizing the debris accumulated on the surface of the cup, which was of the same composition as the debris accumulated on the surface of the head; (c) optical micrograph demonstrating the radius measurement tool in the digital microscope on irregularities found on the surface of the head; (d) SEM micrograph of another area of the head showing particles of biological nature.

In the case of Implant 4, SEM and EDS revealed similar results as in Implant 2, that the debris covering its surface was biological in nature, rich in C, O and N. Implant 4 had the lowest implantation time out of the other 3 samples, demonstrating that the formation of soft tissue reactions does not require extended periods of time of metal ion release into the body. The high level of scratching observed on the interfaces of this implant (Figure 4) could not be quantified due to the homogenous scratch coverage. The surface showed absence of any other features such as delamination, etching or cracks. None of the head-cup interfaces presented discoloration, fretting marks, bulk exposure, or cracks, which are features typically associated with fretting-crevice corrosion [30], confirming the absence of corrosion products on the articulation surfaces. Implant 1 had a Ti6Al4V cup in contrast to the other three implants that had a CoCr alloy cup. The Ti alloy is softer than CoCr, and therefore could be more susceptible to scratching than CoCr interfaces. However, qualitative measurements indicated that both alloys can be subjected to similar degree of scratching.
