## Surface Characterization of Retrieved Metal-on-Metal Total Hip Implants from Patients with Adverse Reaction to Metal Debris

**Abstract:** The use of metal-on-metal (MoM) total hip implants has decreased recently due to reports of high failure rates and adverse local tissue reaction (ALTR). It has been hypothesized that wear metal debris released from CoCr bearing surfaces may provoke delayed hypersensitivity reactions. The goal of this study is to evaluate the microscopic bearing surface characteristics of implants revised due to evidence of ALTR. The bearing surface of each head and cup was analyzed using multiple microscopy techniques for characterization of the surface features. The presence of severe mechanical scratching was a common characteristic found in all of the implants evaluated. Mechanical factors seemed to be the prevalent failure mode related to the appearance of ALTR with this particular set of retrieved implants.

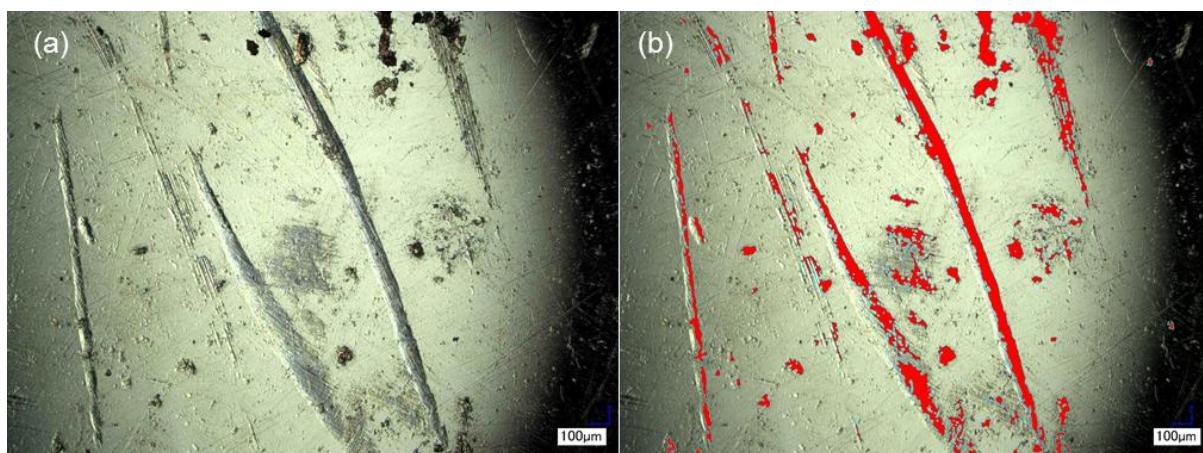
darkness contrast or color difference in the individual image. It provides the overall area of the image and the value of the area selected. Using this feature, the highlighted scratches were selected and the percentage of the area scratched in relation to the total image area was obtained, as shown in Figure 5b. This process was repeated with all the images. The average of the different percentages for each implant was calculated and used to make an estimate of the total area scratched in the entire head interface. This measurement was then used to roughly estimate the area of material lost per year by dividing the total scratched area over the length of implantation.

**Figure 5.** Image of the curved surface of the head of one of the selected CoCr implants taken using the depth-up feature: (a) selected area for analysis; (b) example of technique used for determination of scratch areas, highlighting some of the scratches present on the surface. The actual analysis took all measurable scratches into account that were present on the surface.
